Do you really want to know?

Your MGB is starting to show a few little bubbles in the paint on the lower rear of the front wing. And now you come to look, there are a few along the doorsill too.

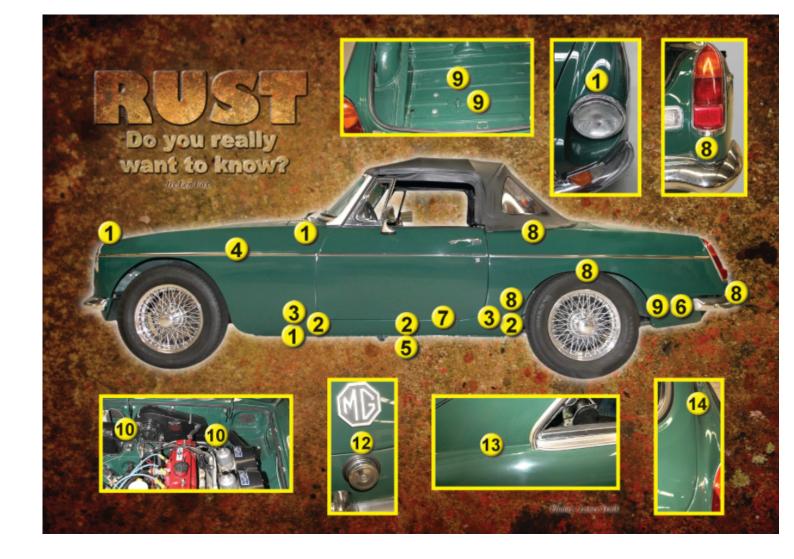
A list of the rust-prone locations around the MGB body shell looks pretty soul destroying. However, not every car will exhibit every possible rust site (with the exception of my GT before restoration!) Knowing where to look before you start repairs helps avoid nasty shocks later. SEE CENTRE PAGES-

- 1. Front Wings. Lower rear, around headlights, scuttle seam.
- Upper front wheel arch reinforcement.Top surface of triangular box section.
- 3. Sills. Inner, outer and centre reinforcement. The ends of the sills are hidden by areas of the front wing lower rear and the rear wing lower front. Sill rust starts in these hidden ends.

- 4. Footwells. Junction of front of floor pan, toeboard & front of inner sill. Similarly at rear of the floorpan.
- 5. Crossmember and sills. Adjacent to jacking points.

- Longitudinal sidemember. Adjacent to rear spring shackle mounts.
- 7. Doors, Lower doorskin, Bottom of doorframe.
- 8, Rear Wings. Lower front, top seam, below tail light assembly, top of wheel arch opening.

- 9. Boot floor. At spare tyre clamp. Where tyre contacts floor.
- 10. Bulkhead shelf. At either side of the heater, inboard of the curved surface which gives steering column clearance. (Best checked from the cockpit.)

- 11. Floor of air inlet plennum chamber. (Remove main air vent door in cockpit.) Additional for GT Model
- 12. Lower area of rear door, rear of boot floor and adjacent external panel. ('Beaver' panel)

- Roof panel immediately behind rear lower corner of side window.
- At top of wheel arch, around upper seat belt anchorage reinforcement plate.
